Renewal of large-scale PS rock anchors in Kawamata Dam foundation

H. Kawasaki

Japan Dam Engineering Center, Tokyo, Japan

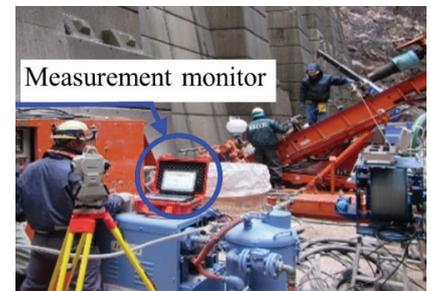
Thus, we obtained data quantitatively such as machine rotation torque, striking pressure, water pressure and drilling speed in real-time. As for tensioning, the measurement of the load-displacement in real time was performed using the tension control system to achieve the high-accuracy tension control.

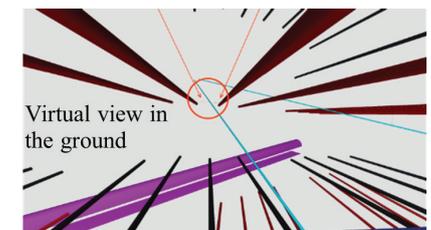
The centralized data management was performed using CIM (Construction Information Modeling) by ground exploration technology, borehole wall observation and so on. It achieved high-accuracy drilling by reflecting the drilling data. Eventually, it enabled more accurate drilling to avoid interference with other underground structures.

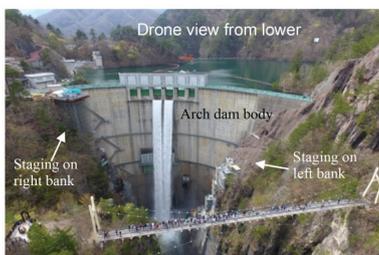
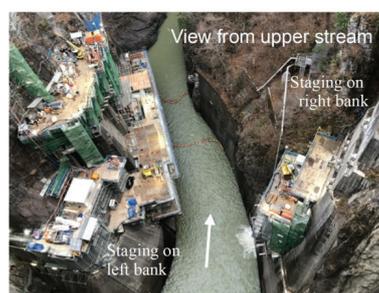
Integrity survey and anti-corrosion on PS anchors

By various integrity surveys, it was confirmed the deterioration of the fully bonded type anchor was very limited, compared to unbonded type. However, pitting corrosions leading to delayed fracture on steel bars were found, and very small step-like displacements were measured.

Considering these facts, the double anti-corrosion protection was decided combining fully bonded type and ECF (Epoxy Coated and Filled) strands. Further, a new non-shrink grout was developed to keep the high quality for 100 years.

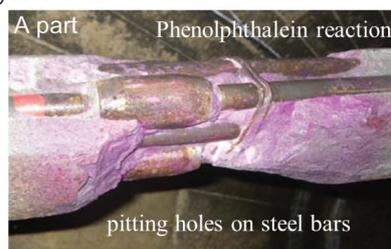
High-pressure resistant cloth packers

Cloth packers weaved by a special fabric was developed for the enough injection under high pressure. This new packer was confirmed through on-site pull-out tests it could increase the frictional resistance greatly around cloth packer by removing only water from grout.

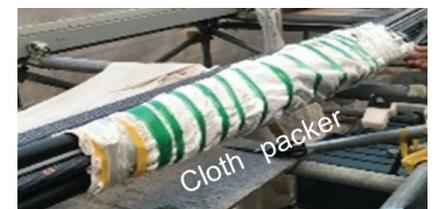
Drilling management

To obtain dynamic information during drilling immediately, ground exploration sounding device was attached to the drilling machine.
