Technical features on the renewal of large-scale prestressed rock anchors in Kawamata Dam foundation

ABSTRACT: Kawamata Dam is a concrete arch dam with 117 m high which was completed in 1966. A huge underground transmitting wall for sustaining the arch thrust force was constructed in the left bank bedrock. In addition, the world largest class prestressed (PS) anchors by total capacity in that time were installed for the purpose of tightening this wall along with too many existed nearby high-angle faults, stabilizing of the bottom of slope and prevention for the surface loosening. Additionally, big retaining walls were constructed to support PS anchors as pedestals. These structures are called bedrock PS works. However, after passing of 50 years, deterioration of PS anchors was confirmed by irregular behaviors observed in measured values, and damages in anchor heads found by integrity surveys for PS anchors. After these anomalies were checked by the technical committee, the renewal plan by the full installation of PS anchors and the repairment of the retaining wall was determined in 2013. From 2014 to 2016, additional surveys, the design of PS anchors for the renewal and detailed c

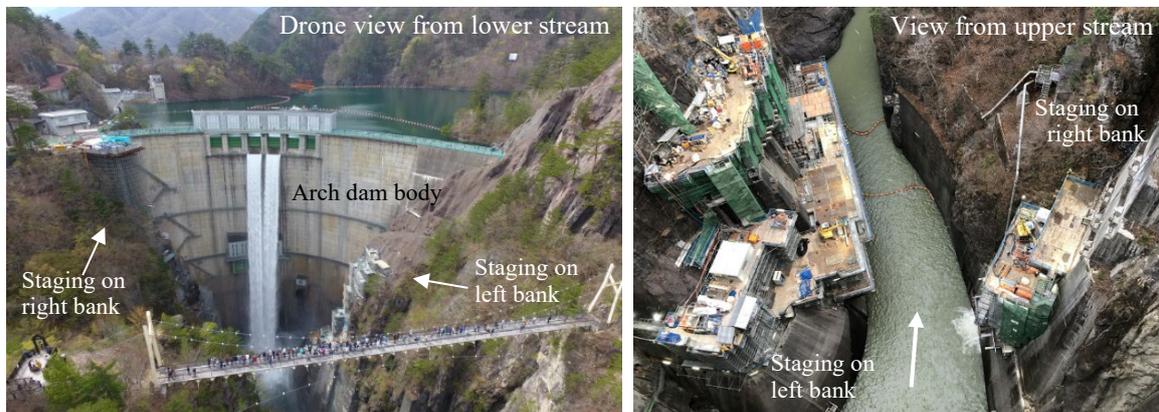
Figure 3. Situation of Kawamata Dam under the renewal works in 2019

In the renewal design, the design load was decided at 2352 kN/unit which is the same as the construction time, to balance with the existing PS anchors. The first phase renewal was executed from 2017 to 2021, and 59 PS anchors, about half of the total 124 anchors, were renewed. Figure 3 shows the working situation on the downstream of the dam. Main materials and machineries were transported by a 4.5-ton cable crane.

On the left bank, due to the steep topography, large-scale temporary construction platforms were installed at each elevation of the PS anchor stage using a sub-tower crane. The right bank was not as extensive as the left bank, but taller scaffolds were erected. Then, very large amount of cement milk (Figure 8) was injected to fill the gap below the back of wall before the anchor works. This bonding of the wall and rock was very effective to stabilize the steep cliff.

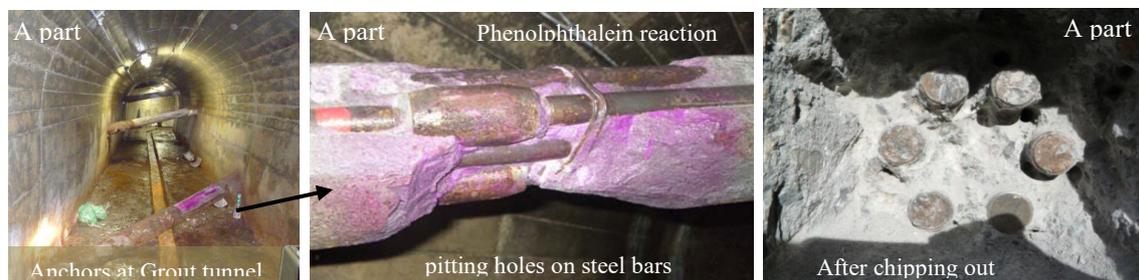
On the other hand, the deterioration of left bank anchors at the full-bond type was limited, but pitting corrosion leading to delayed fracture was observed (Fig. 5), the measured values of rock displacement showed step-like movements, and 60 years had passed since anchor installation. Considering these together, a policy of full renewal of the PS anchors was decided in 2013.

b. Anchor exposure in GG6 pit: Confirmed traces of water infiltration in the mortar around the steel bar. Confirmed partial surface rust and pitting corrosion on the surface of the steel bar confirmed.

Figure 5. Pitting corrosion on a tendon at Grout tunnel and surface looks in an existing anchor

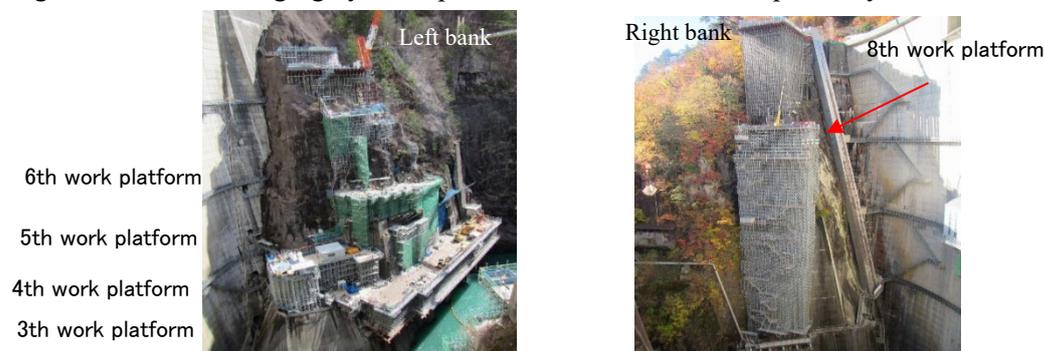
A large-scale work staging platforms covering a steep cliff were erected to install PS anchors. Regarding the structure of the left bank work platform, the first and third rows of the low-elevation parts are less impact of water discharge from dam and in order to install the anchor during the non-flood season when construction is possible, A bracket structure in which each row of work platforms are independent, was adopted.

The system scaffolding was set up from the third stair bracket work platform. The structure of the right bank work platform is a system scaffolding, and the scaffolding was set up from lower to upper when slash grouting was performed before installing anchor. At the time of anchor work, the system scaffolding was dismantled for each anchor work step (8m).

Figure 9 shows the staging by work platforms on both banks, respectively.

Figure 9. Large-scale Staging by work platforms on the left bank and right bank

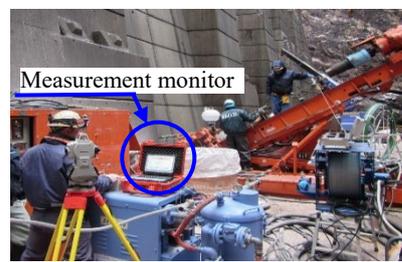
The drilling accuracy of all holes was confirmed at the middle point of drilling, using during drilling measurement device with a gyro and an acceleration sensor. In addition, the full-length measurement was also carried out for 10% of installed anchor (Fig. 10b).

a. Drilling situation by ground exploration technology b. Measurement circumstance of hole bending

Figure 10. Drilling and measurement

Table 4 shows the measurement results of hole bending. Accuracy confirmation during drilling enables early detection of an increase in hole bending and countermeasures against defects. Therefore, it was a useful means of construction management based on the suppression of process delays.

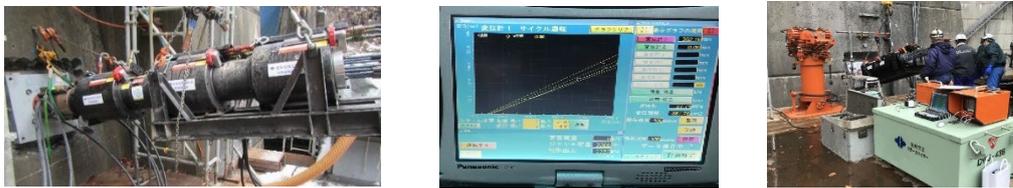
In tensioning work, when the amount of elastic displacement is large, the stroke of the jack is insufficient with a conventional single tensioning jack, and replacement work is required.

Therefore, a large jack coupling system was devised that couples 2 or 3 jacks according to the anchor length, enabled to tension work without replacing the tension jack. In addition, we confirmed that the measurement results of the load-displacement in real time using the tension control system. We achieved high-accuracy tension control by combining these technologies (Fig. 13).

Figure 13. Triple coupled large tension jacks and tension control system

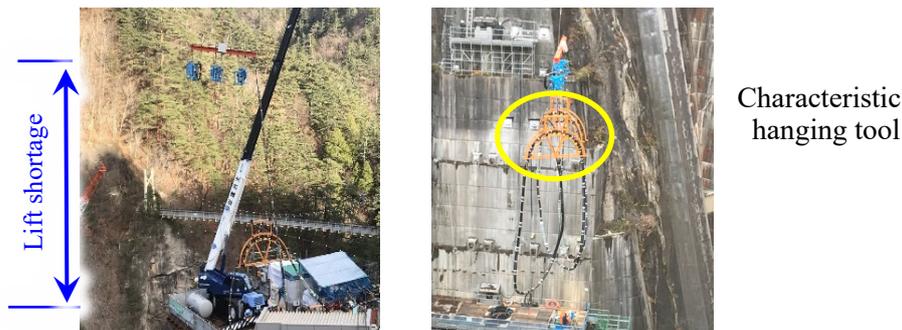
Tendons must be transported in such a way that the twisted, sharply bent, adhered with harmful substances, or damaged in anticorrosive materials, which are not damaged. The tendon of this project is about 50m long and weighs about 1 ton, so its handling is not easy.

In addition, the site condition is not suitable for tendon transporting by hanging from its assembly yard. Therefore, in transporting tendons, we developed a semi-circular characteristic hanging tool that makes the tendon curve smoothly so that no concentrated load is generated on the suspension part, and the tendons were transported by folding it in two or three (Fig. 14).

Figure 14. Tendon transport lifting tool
